**HYDROLOGICAL LEVEL 2
TECHNICAL REPORT
ST. MARYS FLAMBOROUGH
QUARRY**

File No. 160960345

St. Marys Cement (Canada Inc.)

January 2009

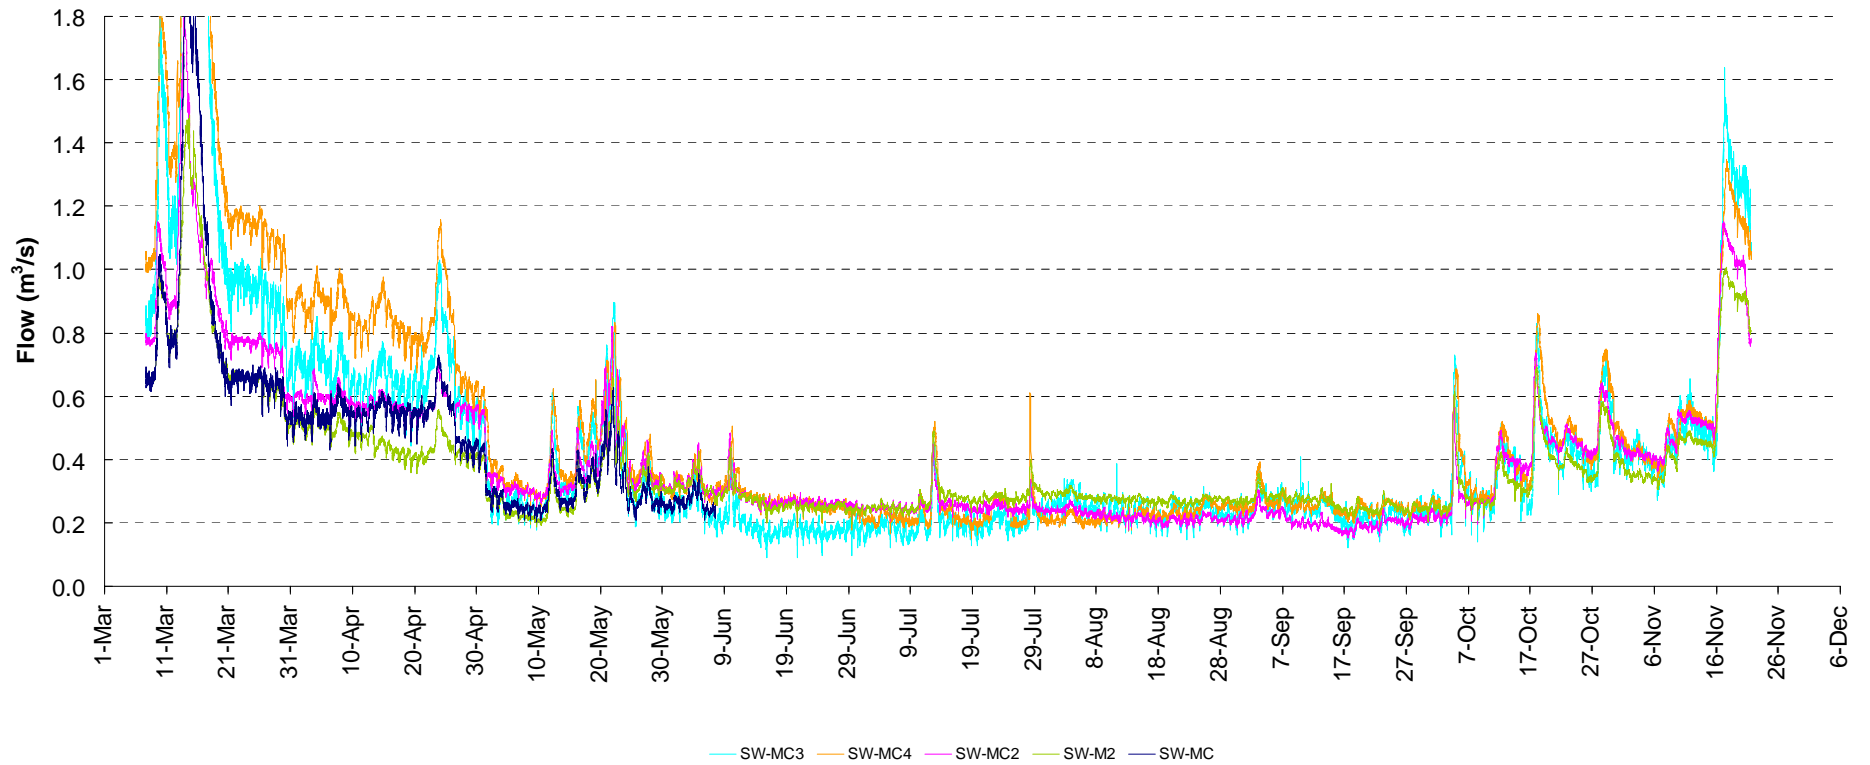
Title
MOUNTSBERG CREEK FLOWS, 2006

The 2006 flow monitoring data for the five Mountsberg Creek stations (SW-MC, SW-M2, SW-MC2, SW-MC3, and SW-MC4) are shown in **Figure 10 (Appendix A)** along with daily monitored rainfall. Greater than average precipitation was experienced in 2006 (approximately 1100 mm as compared to the climate normal of 973 mm). Consequently, several snowmelt and rainfall runoff events were observed during 2006. Spring and fall peak flows at all stations surpassed 1 m³/s, with summer base flows generally remaining above 0.200 m³/s. An average increase in flow of approximately 0.047 m³/s was observed between station SW-MC2 at Mountsberg Road and station SW-MC3 at Concession 11. Similarly, an average increase in flow of about 0.055 m³/s was observed between station SW-MC3 station SW-MC4 at Concession 10. However, only marginal to no differences in flow were observed between these stations during summer months.

Continuous flow monitoring results for all Mountsberg Creek and tributary stations for the period 2006-2007 (inclusive) are shown in **Figures 10 to 13 (Appendix A)**. Due to the very dry conditions experienced in the fall of 2005, the continuous flow monitoring data set for 2005 is limited in nature and is not discussed here, but is included in Appendix C. Monitoring of Station SW-MC was suspended in the spring of 2006 due to land access issues. With the consent of property owners, this station was re-established in the spring of 2007.

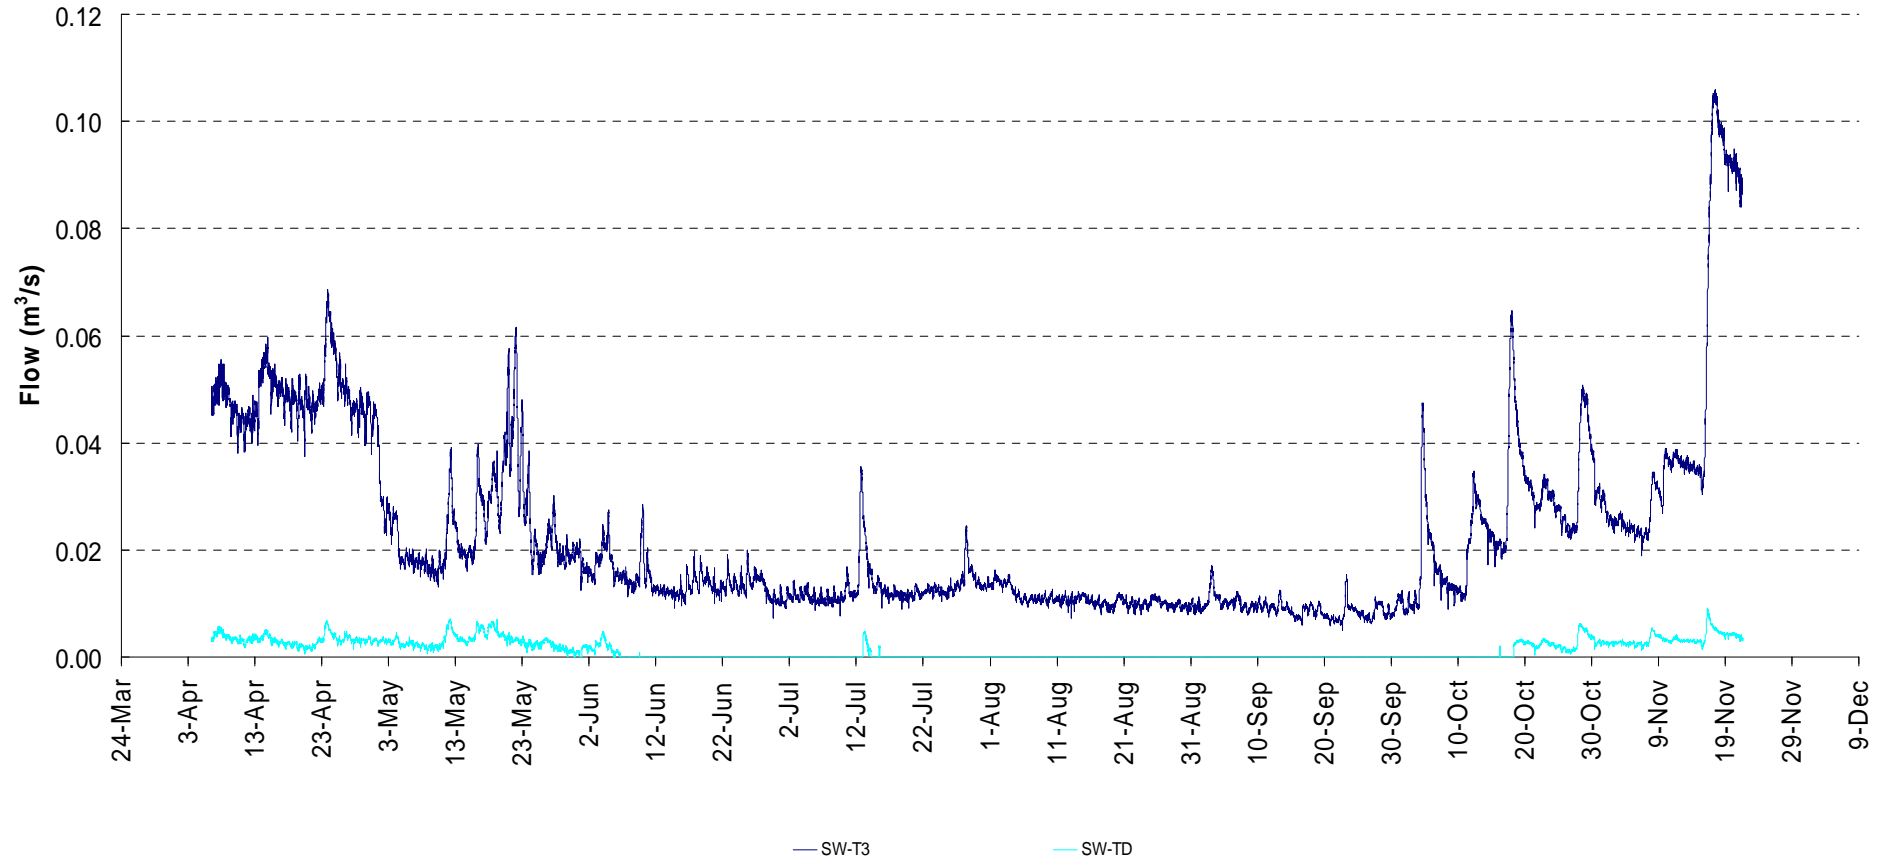
Title
MOUNTSBERG TRIBUTARY
CREEK FLOWS, 2006

An average flow of approximately 0.023 m³/s was observed in Tributary A for the monitoring period (**Figure 11, Appendix A**). This flow rate was observed to fall to approximately 0.007 m³/s in September, 2006. Similarly, an average flow of approximately 0.0013 m³/s was observed in Tributary D for the monitoring period (**Figure 11, Appendix A**). Except for a brief response to an intense rainfall event in mid-July, no flow was observed in Tributary D from early June to mid-October, 2006.

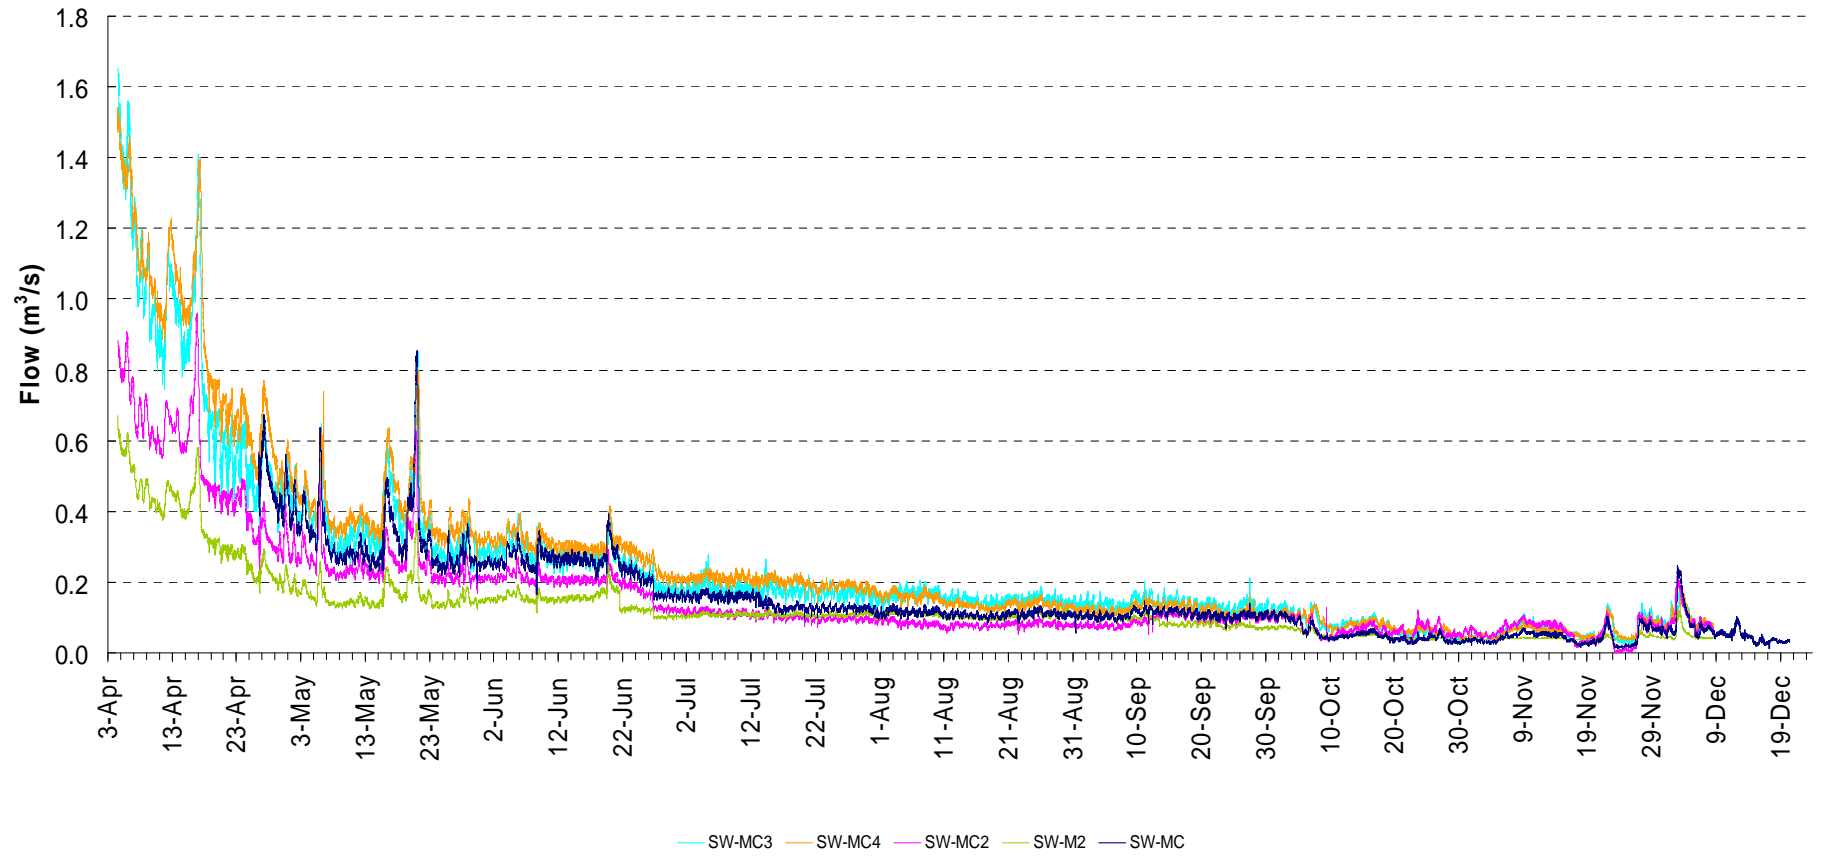
Title
MOUNTSBERG CREEK FLOWS, 2007

The 2007 flow monitoring data for the five Mountsberg Creek stations are shown in **Figure 12 (Appendix A)** along with daily monitored rainfall. Below average precipitation was experienced in 2007 (approximately 724 mm as compared to the climate normal of 973 mm). Consequently, flows at all stations were considerably lower than in 2006, with few rainfall events observed following the spring freshet. An average increase in flow of approximately 0.026 m³/s was observed between station SW-MC2 at Mountsberg Road and station SW-MC at Evergreen Road. Further downstream, average increases in flow of about 0.028 m³/s, and 0.019 m³/s were observed between stations SW-MC and SW-MC3, and stations SW-MC3 and SW-MC4, respectively. Once again, only marginal to no differences in flow were observed between these stations during the summer, and, particularly, fall months. This was likely the result of the considerably reduced precipitation observed in the spring, summer, and fall.

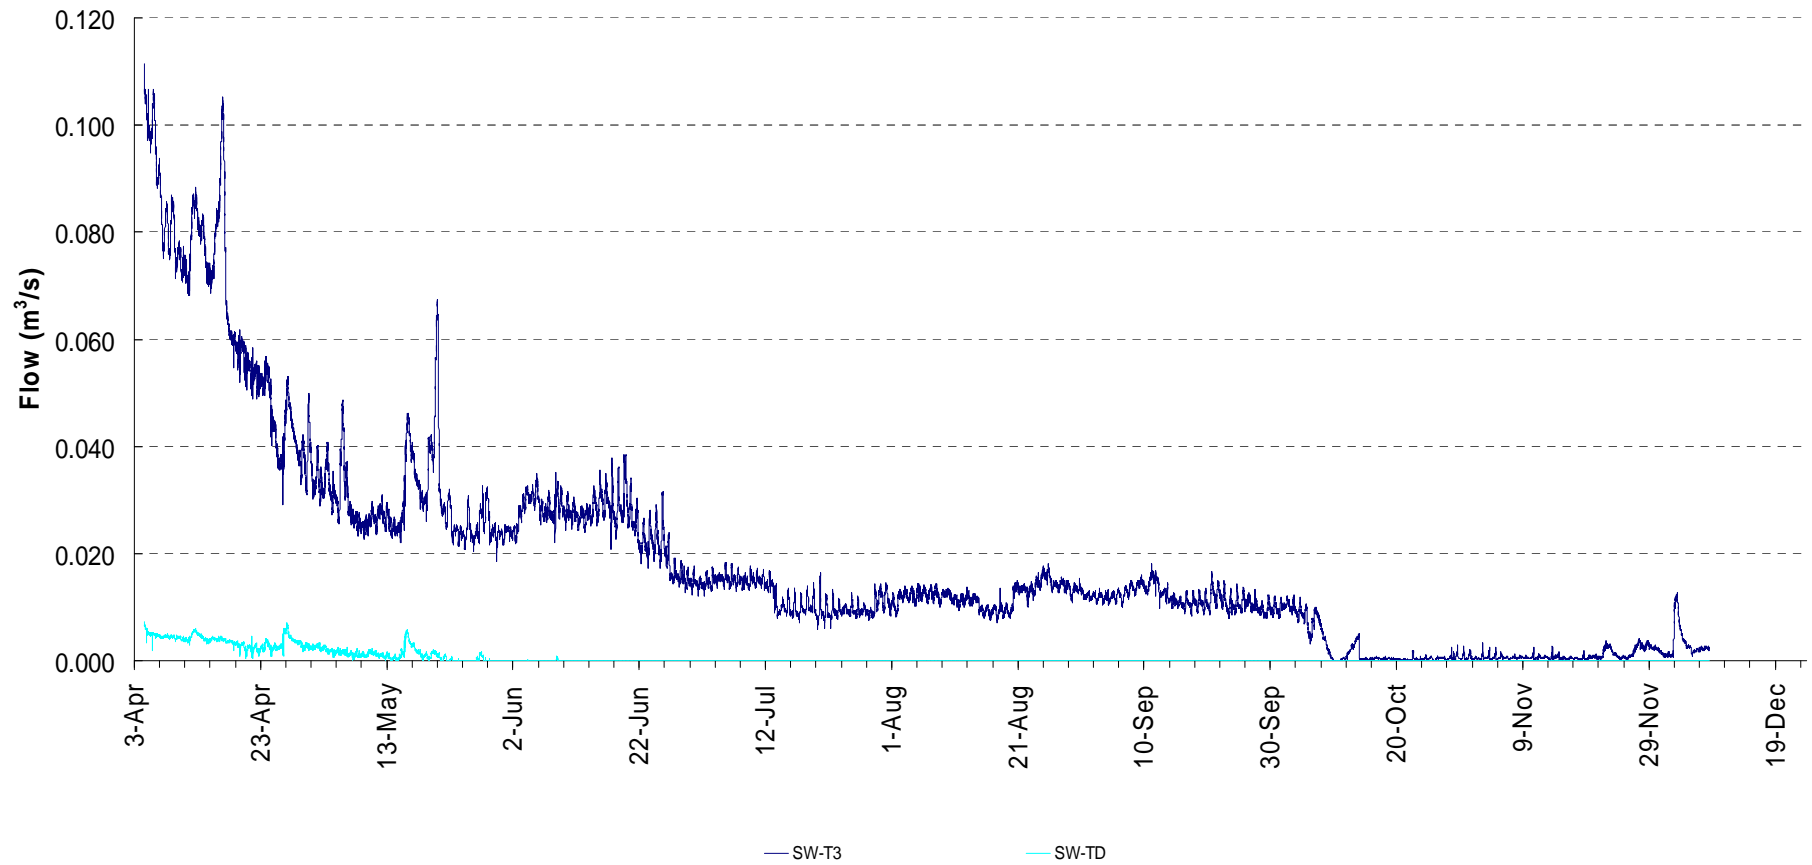
Title
MOUNTSBERG TRIBUTARY
CREEK FLOWS, 2007

With respect to the Mountsberg Creek tributaries, an average flow of approximately 0.018 m³/s was observed in Tributary A for the monitoring period (**Figure 13, Appendix A**), which is lower than the 0.023 m³/s mean observed in 2006. Flows were observed to fall to near zero levels in the fall of 2007. Flows in Tributary D averaged only 0.0005 m³/s for the monitoring period, with zero flow observed at SW-TD from early June on.

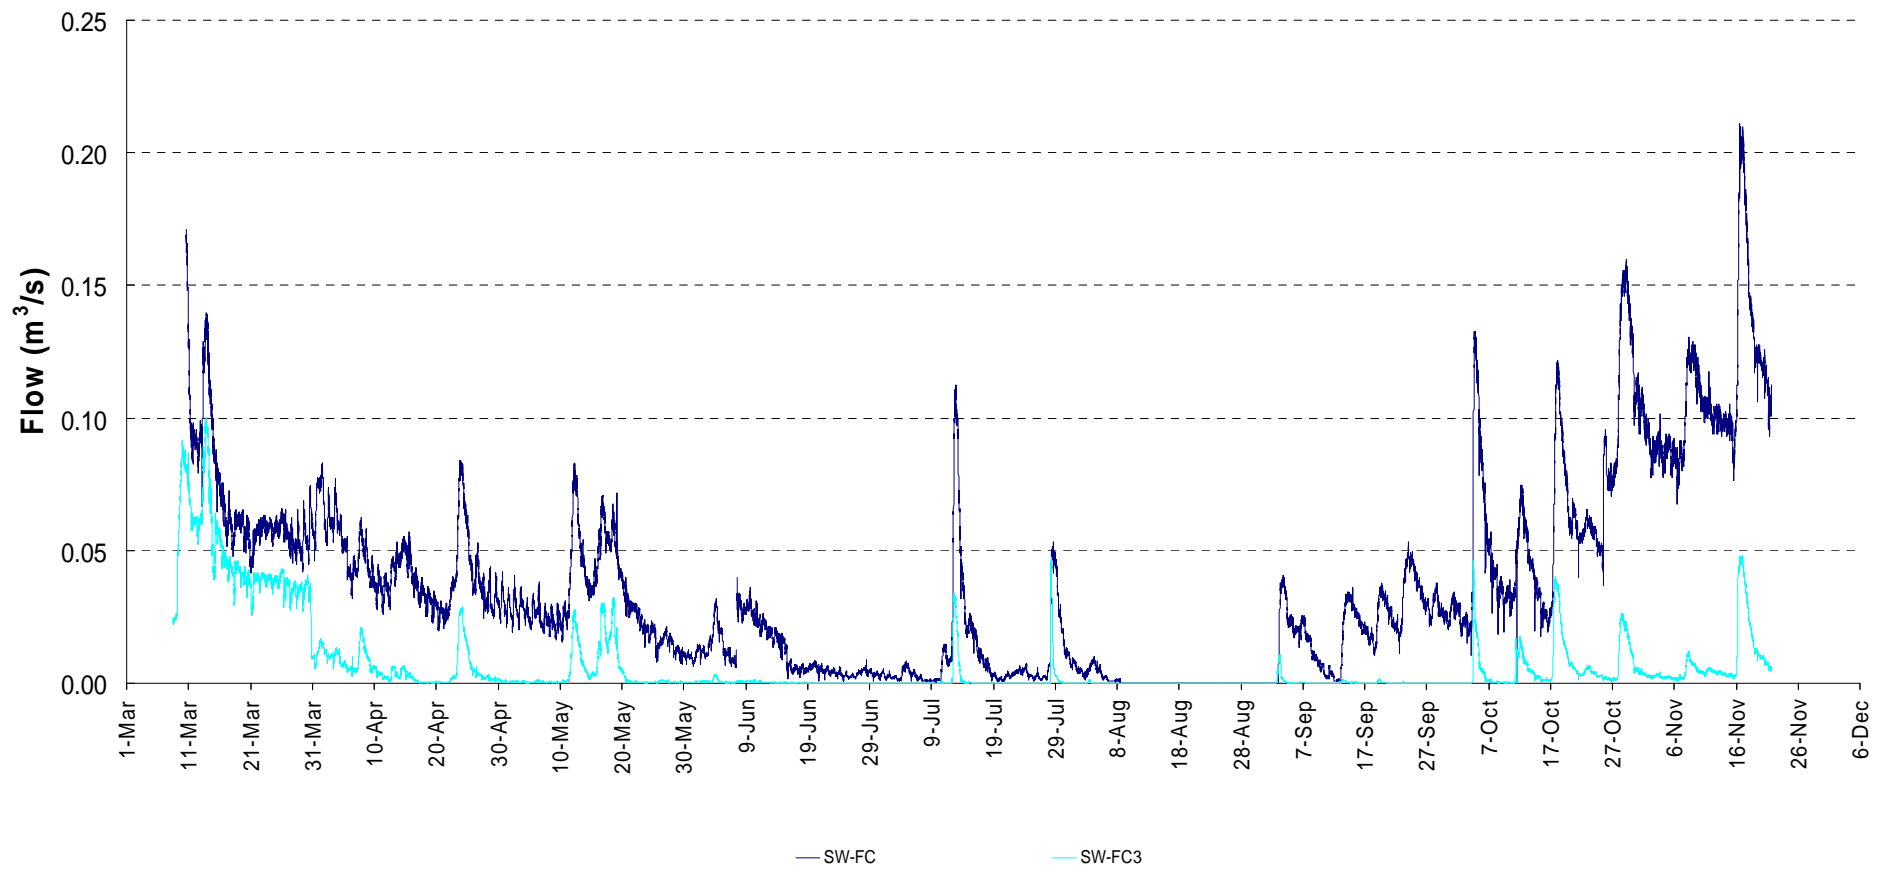
Title
FLAMBORO CREEK FLOWS, 2006

Observed flows in Flamboro Creek for 2006 and 2007 are presented in **Figures 14 and 15 (Appendix A)**. Flows at Concession 11 averaged approximately 0.037 m³/s in 2006 with zero to near zero flow levels in August. Flows responded to snowmelt or rainfall runoff events, and did not appear to be strongly influenced by groundwater inputs. Mean flows at SW-FC3 were 0.007 m³/s over the monitoring period. However, it must be recalled that the majority of flows in Flamboro Creek at this location were not captured by this monitoring station. In 2007, flows at Concession 11 averaged approximately 0.005 m³/s in 2006 with zero flow levels observed from late June on. Mean flows at SW-FC3 were approximately 0.002 m³/s over the monitoring period.

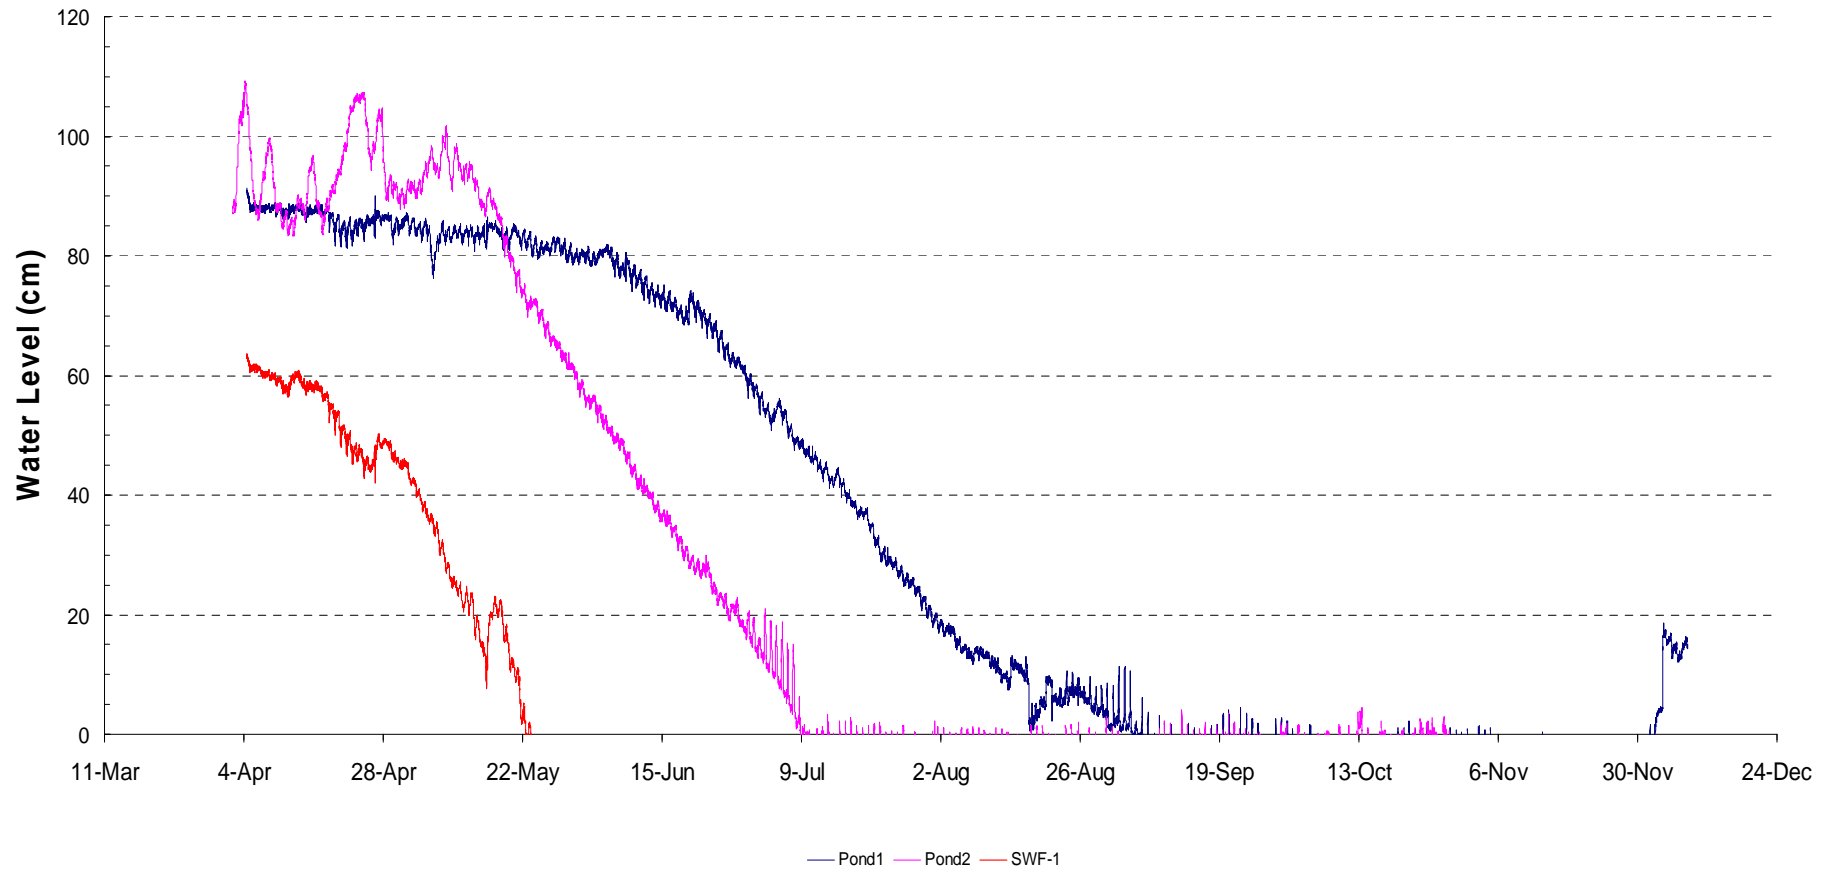
Figure No.
17

In contrast, in 2007, all surface water features failed to sustain water storage throughout the entire monitoring period. Hydro-periods for these three features were considerably reduced, with ponding disappearing from station SWF-1 by May 23. Surface water storage essentially disappeared from the dugout pond (Pond 2) at the monitoring station by July 10, while ponding ceased to occur at the Pond 1 station by September 6, and then returned by early December.

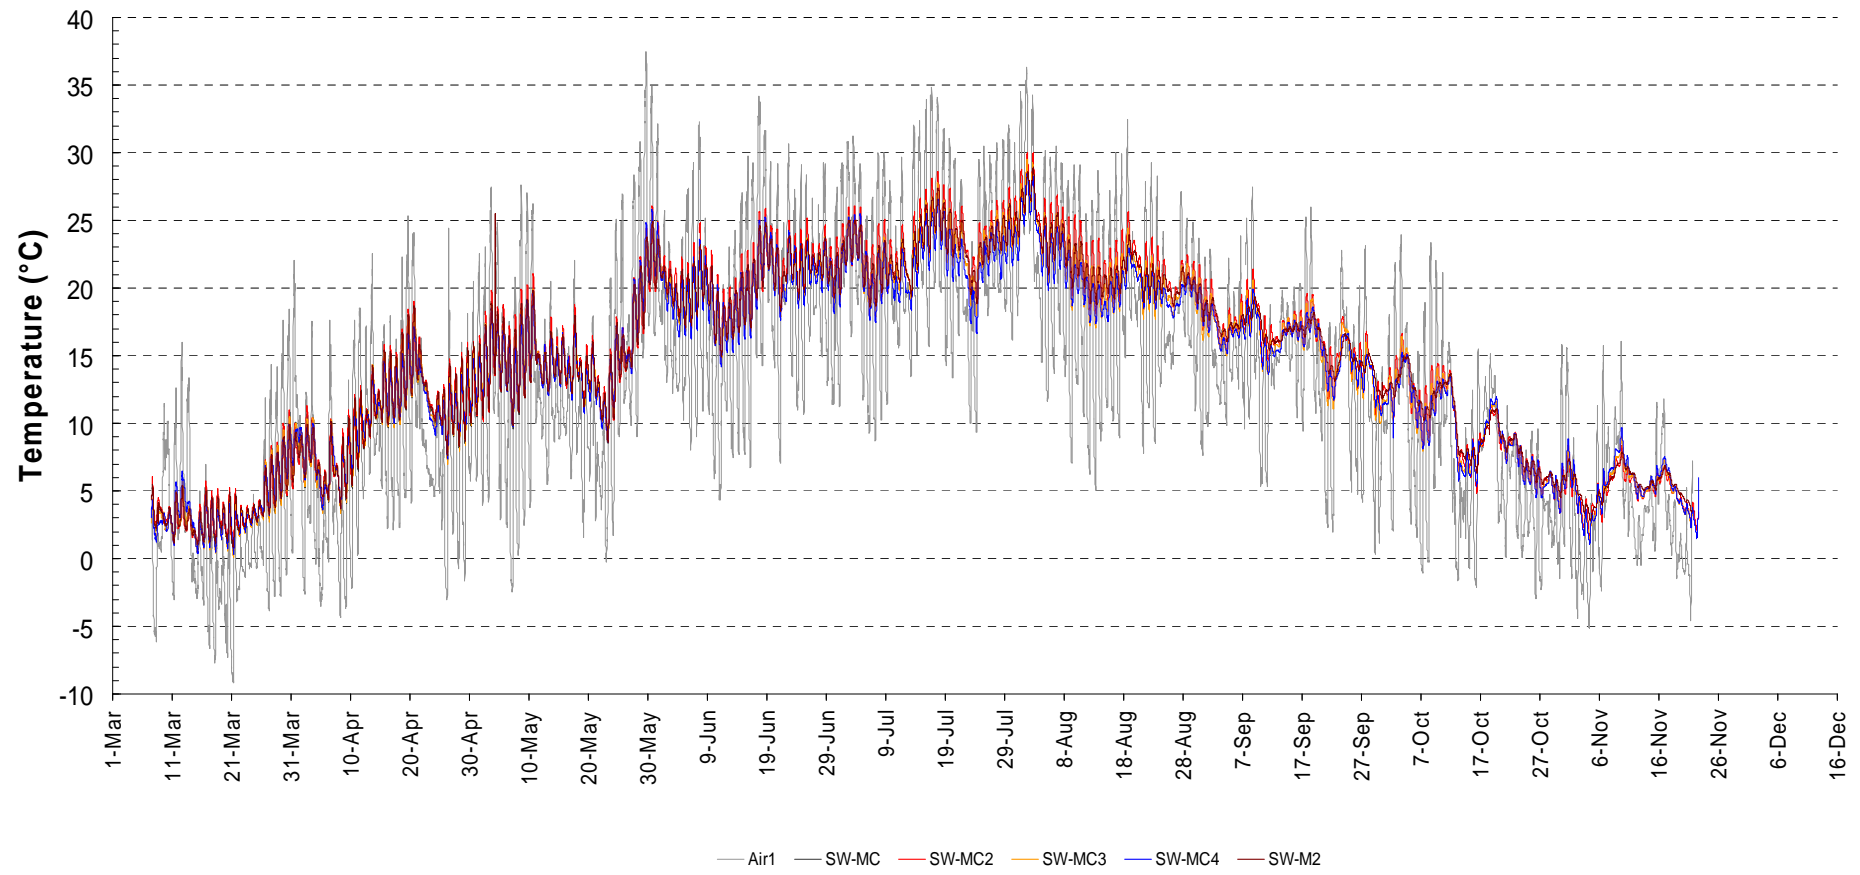
Title
MOUNTSBERG CREEK
TEMPERATURES, 2006

Observed temperatures in Mountsberg Creek and its tributaries for 2006 and 2007 are presented in **Figures 22 to 25 (Appendix A)** along with observed air temperatures. Although temperatures are fairly consistent from upstream to downstream stations, a slight cooling of Mountsberg Creek was discerned through the temperature monitoring data. From early June to late September 2006, temperatures in Mountsberg Creek averaged 18.42 °C at SW-MC2, 18.22 °C at SW-M2, 17.90 °C at SW-MC3, and 17.65 °C at SW-MC4 (the recorded temperature data at SW-MC is incomplete and is therefore not compared to other stations). In comparison, the

Observed temperatures in Mountsberg Creek (**Figure 22 to 25, Appendix A**) demonstrate a lower degree of variability than temperatures in Tributary A or Flamboro Creek. This is likely due to the greater net volumetric flow through Mountsberg Creek. Although characterized by considerably lower flows than Mountsberg Creek and minimal canopy cover, Tributary A was observed to reach lower average daily temperatures than Mountsberg Creek from late spring (early June) to early fall (late September). Temperature fluctuations in Tributary A are likely buffered as a result of groundwater inputs. However, the temperature data suggest minimal temperature buffering capacity in Tributary A during summer months. Water quality data suggest that roughly 50% of flows in Tributary A may be sustained by groundwater inputs from late fall to mid to late spring. The magnitude and duration of such inputs is likely correlated with on-site seep activity. Groundwater inputs to Tributary A approach zero during summer months. Tributary A exerts a slight cooling effect on Mountsberg Creek. Although groundwater ponding is evident in the headwaters of Flamboro Creek, flows in Flamboro Creek responded to snowmelt or rainfall runoff events, and did not appear to be strongly influenced by groundwater inputs. Such inputs occur in downstream reaches of Flamboro Creek.

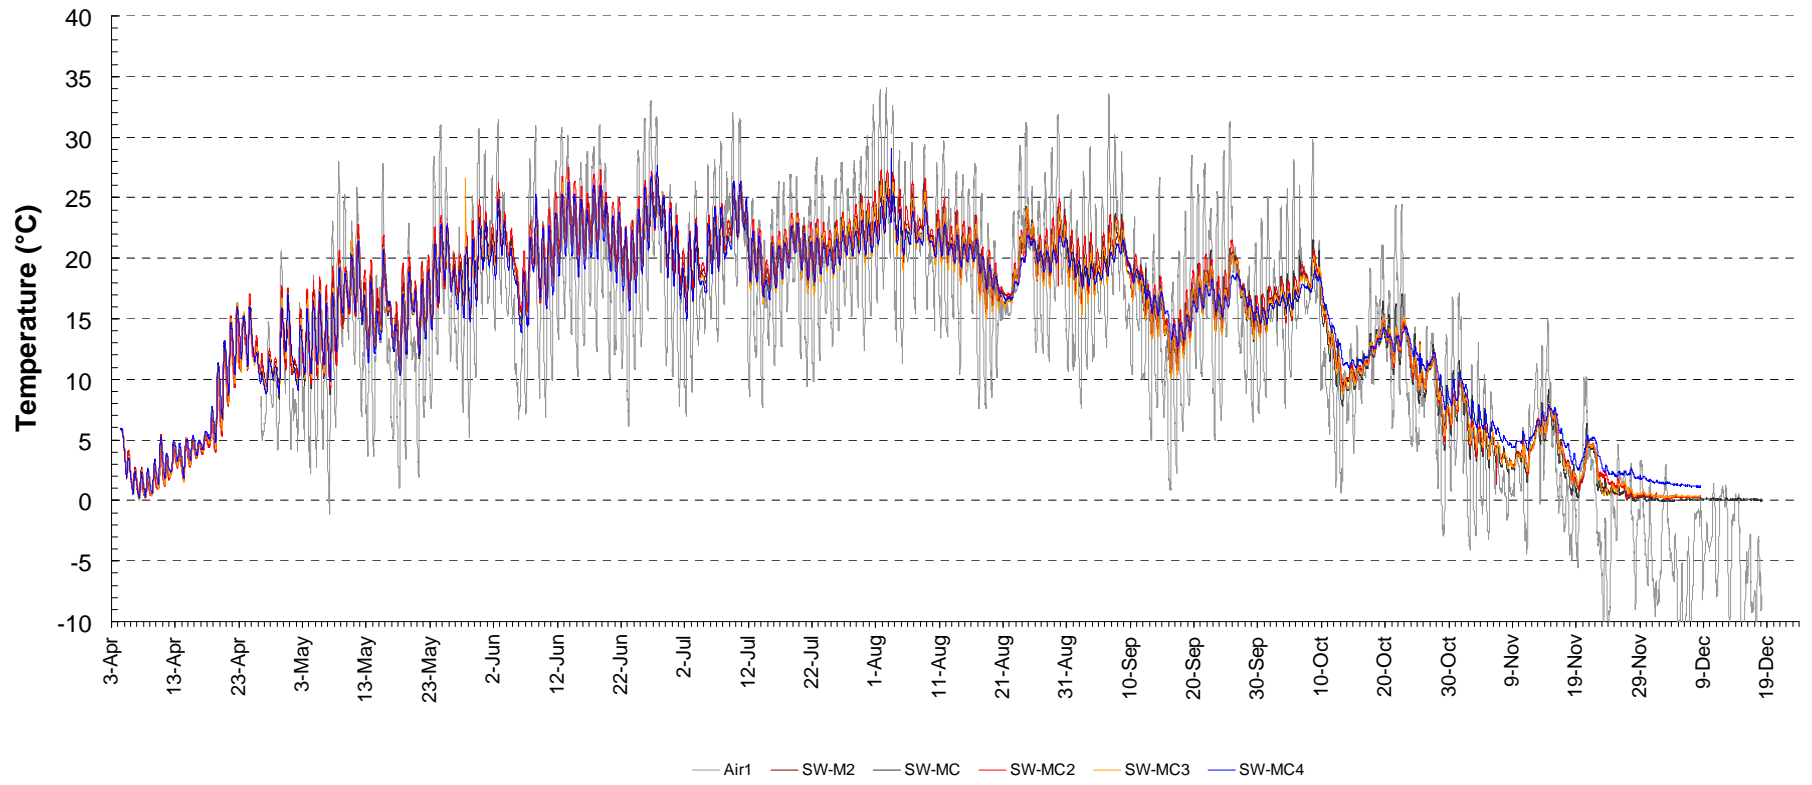
Figure No.
24

Similarly, from early June to late September 2007, temperatures in Mountsberg Creek averaged 20.55 °C at SW-MC2, 20.27 °C at SW-M2, 20.06 °C at SW-MC, 19.81 °C at SW-MC3, and 19.84 °C at SW-MC4. The reduced flows experienced in 2007 resulted in greater creek temperatures (approximately 2 °C) when compared to 2006 data. Additionally, a slight increase in temperature was noted as creek water flowed from SW-MC3 to SW-MC4, in contrast to the 0.25 °C decrease witnessed in 2006. The average temperature within Tributary A was 18.80 °C over the same time period. While cooler than all the Mountsberg Creek stations, this temperature represents a 2.5 °C increase over mean 2006 temperatures in Tributary A.

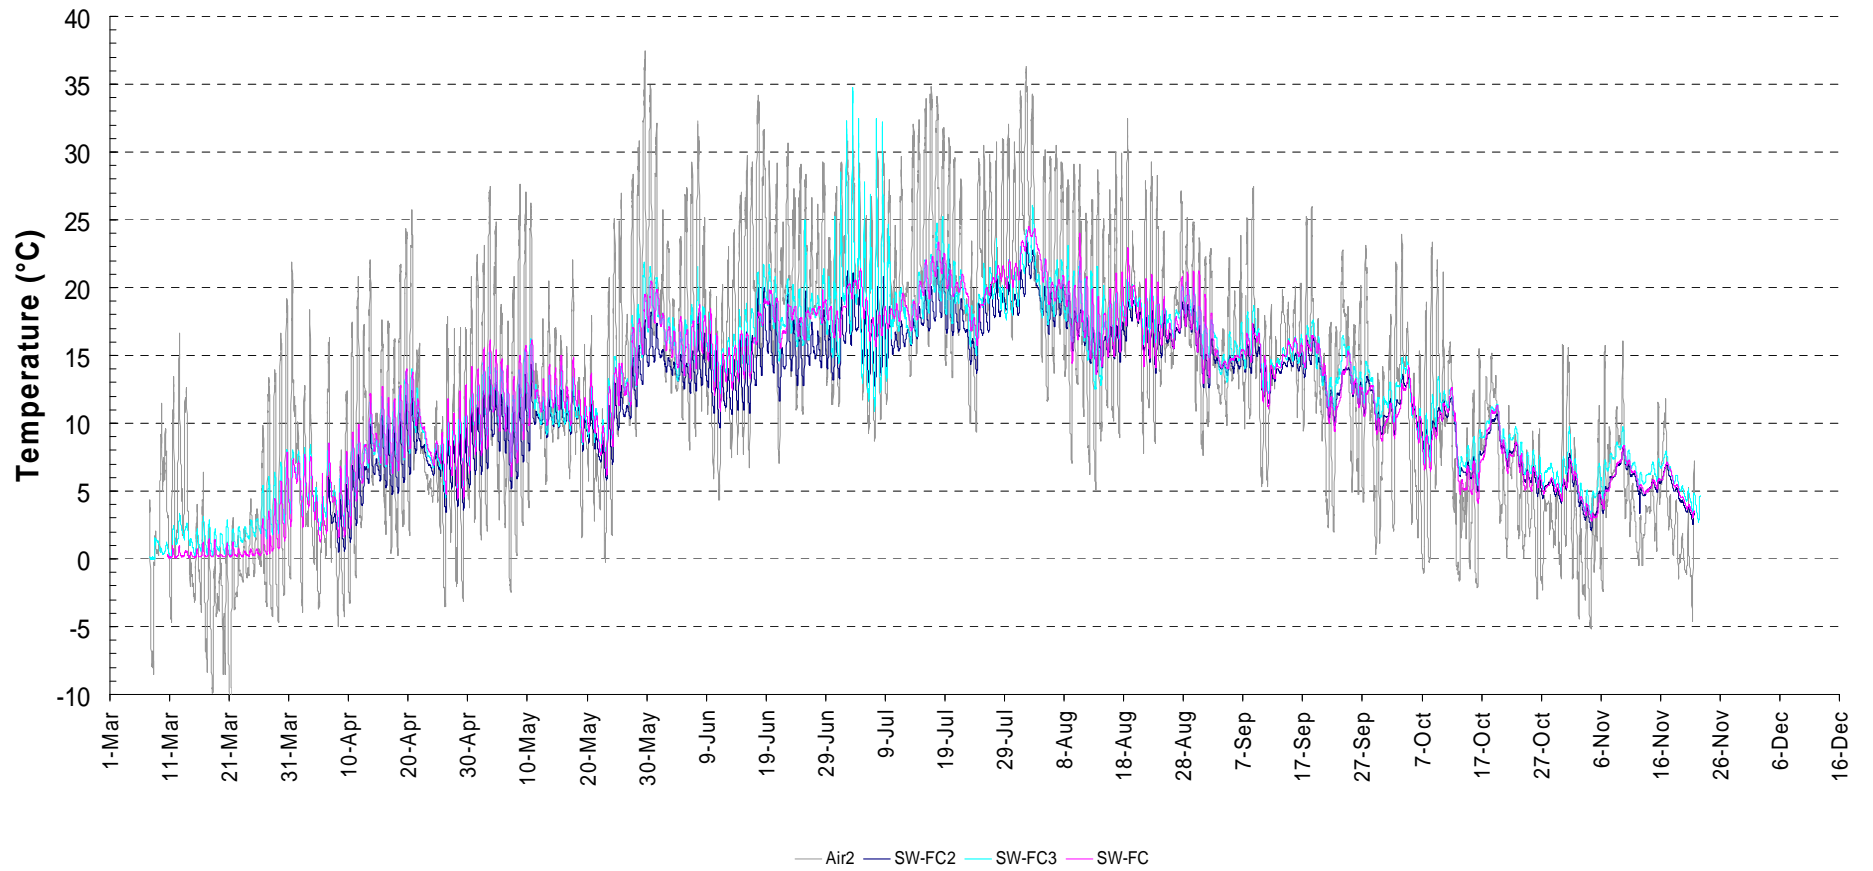
Figure No.
26

Temperatures in Flamboro Creek in 2006 and 2007 (**Figures 26 and 27, Appendix A**) experienced a slight increase from upstream to downstream stations. Average temperatures of 13.47 °C, 15.09 °C, and 15.24 °C were observed at stations SW-FC2, SW-FC, and SW-FC3, respectively from early June to late September, 2006. A lack of observed flows in Flamboro Creek during the summer and fall of 2007 render temperature comparisons between stations difficult. However, it is noted that temperatures averaged 7.91 °C at SW-FC2 and 9.55 °C at SW-FC from early April to early June, 2007.

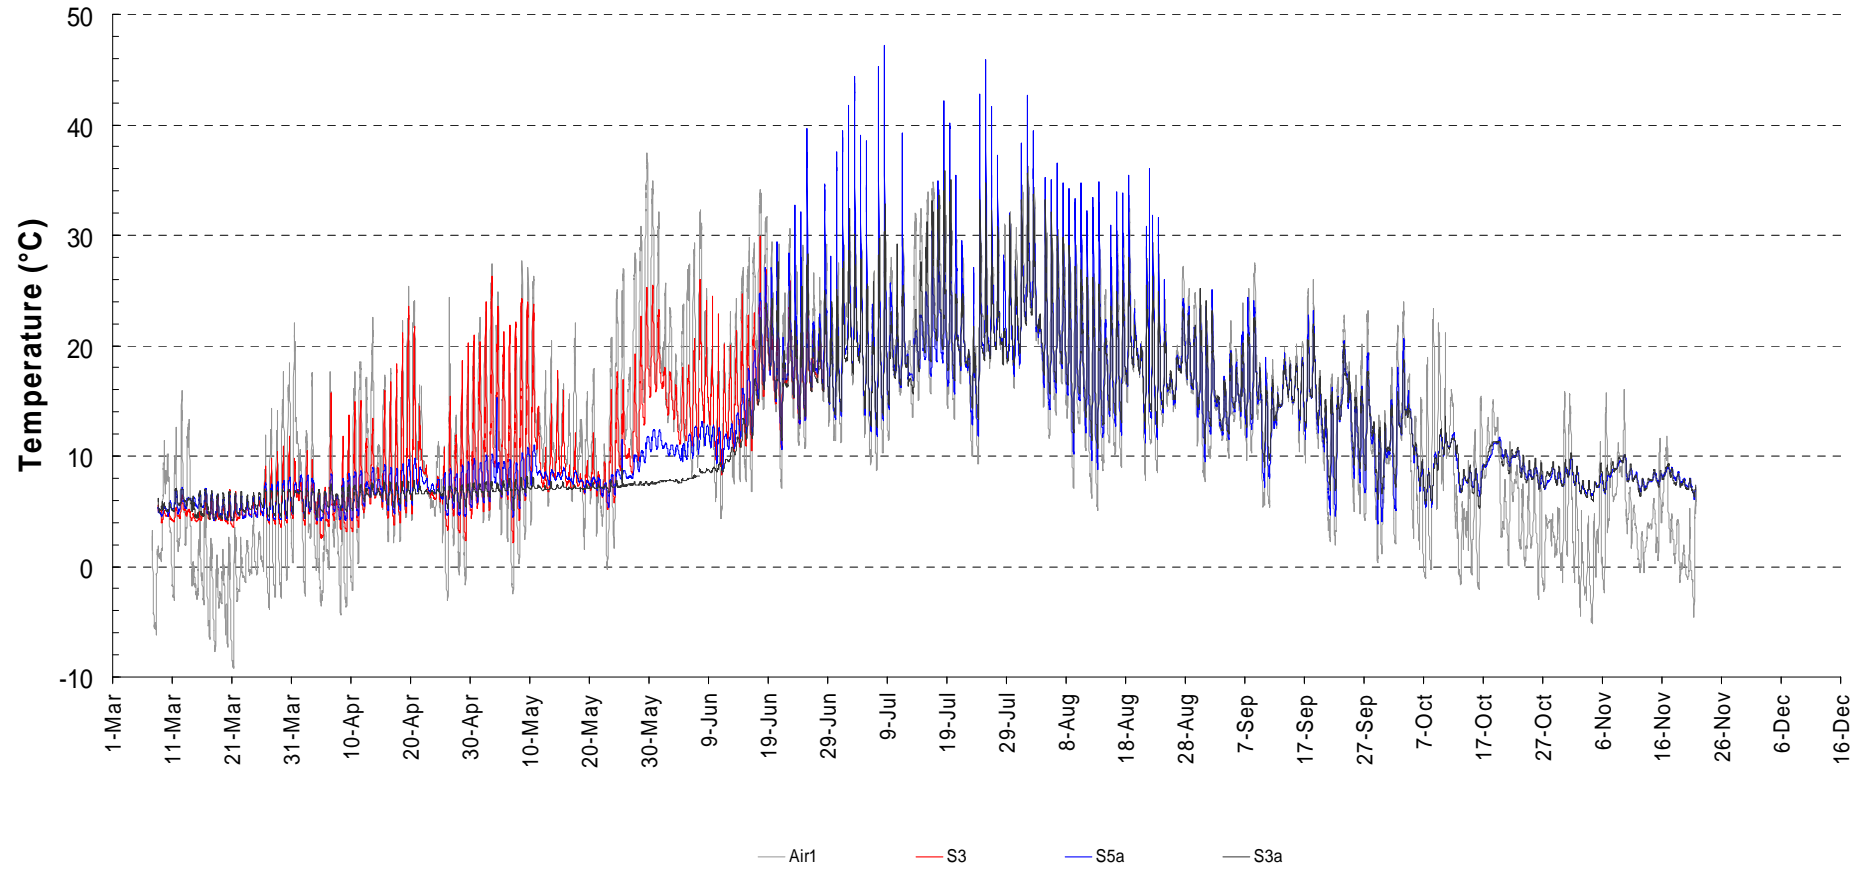
Figure No.
30

ceased in mid-June (**Figure 30, Appendix A**). Seep temperatures averaged 6.86 °C at S3a and 7.73 °C at S5a from early April to mid-June, 2006. Similarly, seep temperatures at S3a and S5a in 2007 remained below 15 °C until reduction in seep activity accelerated in early June (**Figure 31, Appendix A**). Seep temperatures averaged 8.44 °C at S3a and 9.45 °C at S5a from early April to early June, 2007. This represents an approximate 1.5 °C increase over mean 2006 temperatures. The sporadic seep activity observed at S3 resulted in much greater temperature variation at this station during both years.
